TEST REPORT

Report No.: J1906056R01E Report Date: 2019/07/16 Page: 1 of 56

Sample Name : 16-lines Lidar
 Sample Model : C16
 Sample Quantity : 9 pcs
 Sample No. : A1、 B1、 C1、 D1、 E1、 F1、 G1、 H1、 I1
 Applicant No. : /
 Manufacturer : Leishen Intelligent System Co., Ltd.
 Receiving Date : 2019/06/06
 Test Period : 2019/06/17~2019/07/08

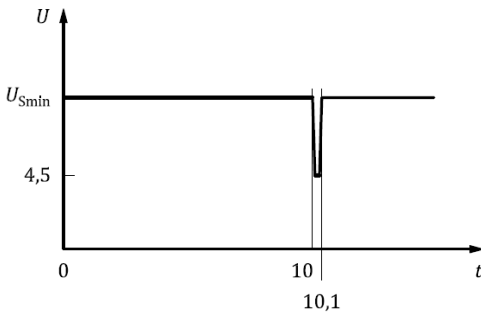
<p>U—Voltage, V; t — Time, seconds.</p>			
Acceptance Criteria	The functional status shall be minimum class B, that is, during the test, one or more functions fail to meet the requirements is allowed, but required to automatically return to normal, and the function is the sample imaging function.			
Deviation	/			
Test Results	Visual inspection on the sample after the test, no abnormalities on appearance, function satisfies the B-level requirement.			
Test Instruments	No.	Equipment Name	Equipment Number	Calibration Due Date

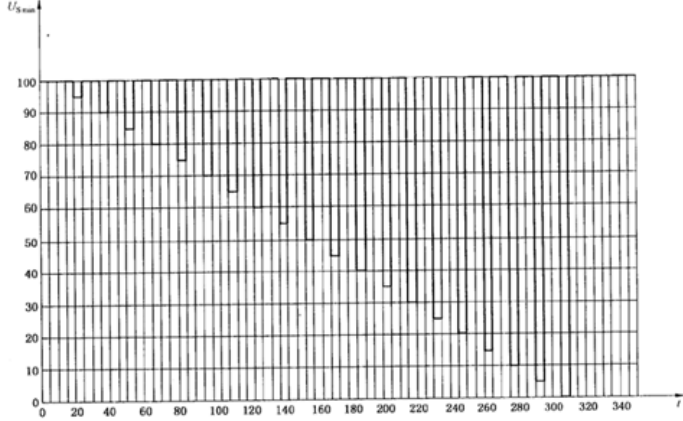
<p>U_{smin}— Minimum supply voltage, %; t—Time, seconds.</p>			
Acceptance Criteria	The functional status shall be minimum class C, that is, during the test, one or more functions fail to meet the requirements is allowed, but required to automatically return to normal, and the radar imaging is normal.

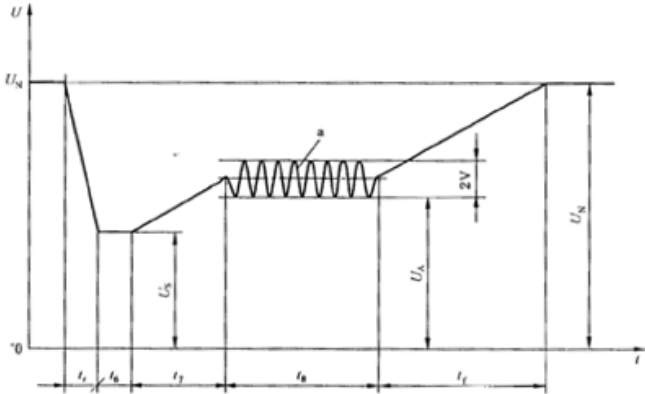
Sample No.	A1																																																																																			
Refer Specs	GB/T 28046.2-2011 Road vehicles-Environmental conditions and testing for electrical and electronic equipment-Part 2: Electrical loads 4.6.3																																																																																			
Test Method	<p>The sample is energized according to the start-up characteristic parameters given in the figure and table. A total of 10 tests are performed with an interval of 1 s~2 s between each cycle. The starting voltage curve is as follows:</p>

<p>Test parameters as below:</p>

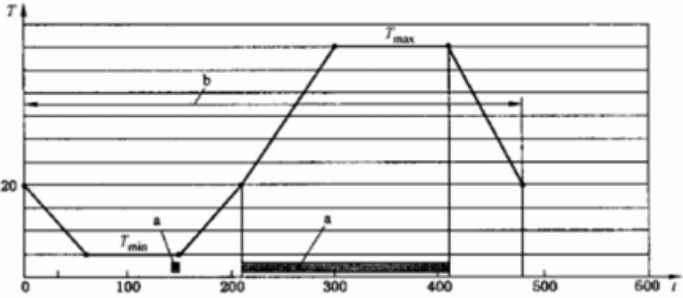
<p> t—Time, min; T—Temperature, °C; a— Mode 3.2; b— one cycle. </p> <p>In the period of work mode 3.2, after the whole device temperature reaches -20 °C, the sample is energized, the function of the sample is checked and temperature is 12 V DC between the 210 min and the 410 min in a single temperature cycle, the sample is not energized for the rest of the time.</p> <p>Vibration condition</p>

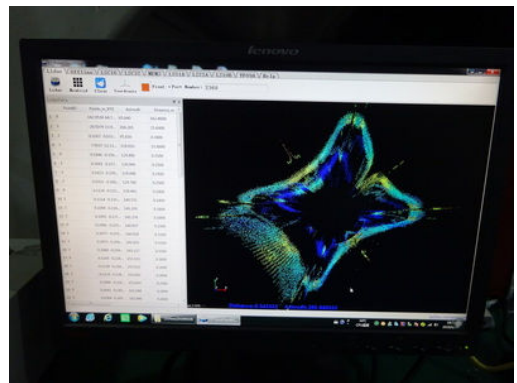
Fig.R07.5 During the test setup schematic photo

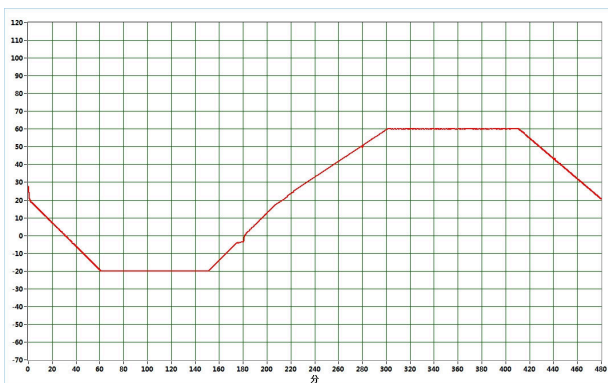
Fig.R07.9 Curves of temperature X axis

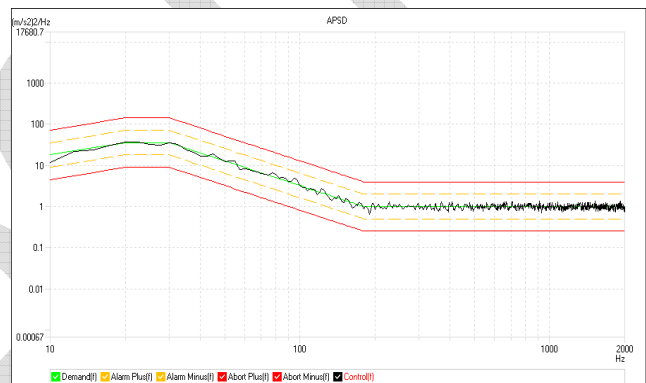
Fig.R07.10 Curves of vibration X axis

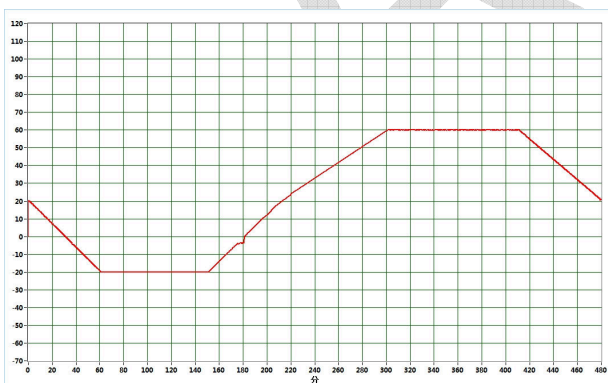
Fig.R07.11 Curves of temperature Y axis

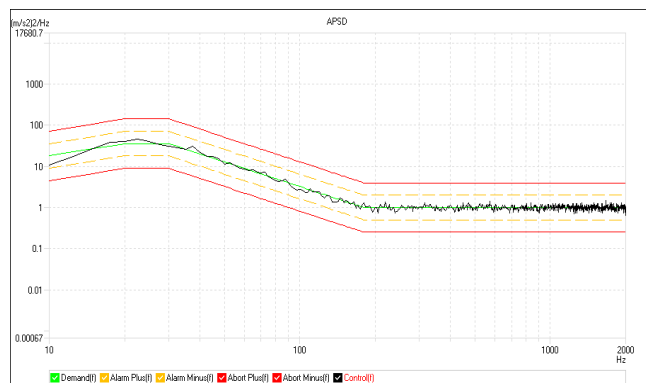
Fig.R07.12 Curves of vibration Y axis

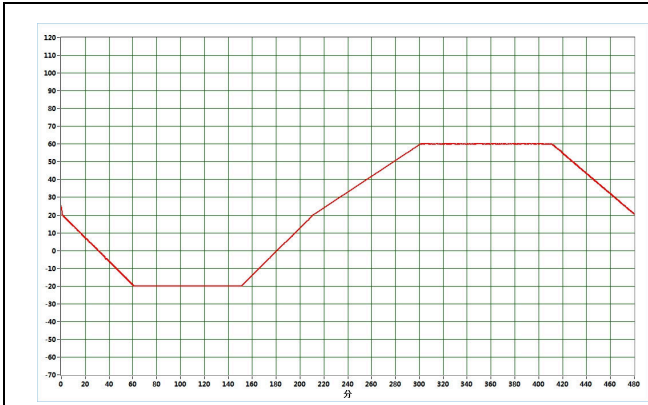
Fig.R07.13 Curves of temperature Z axis

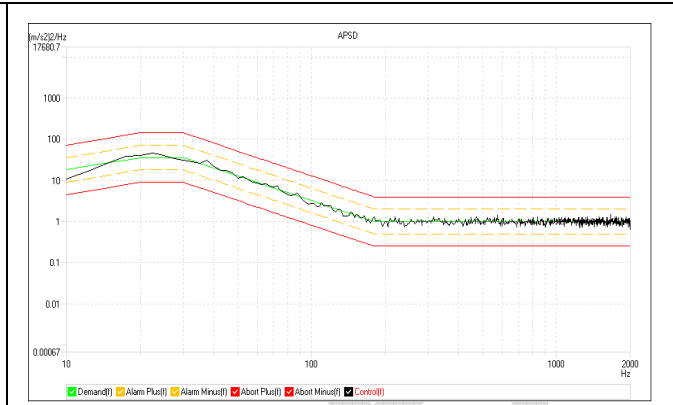
Fig.R07.14 Curves of vibration Z axis

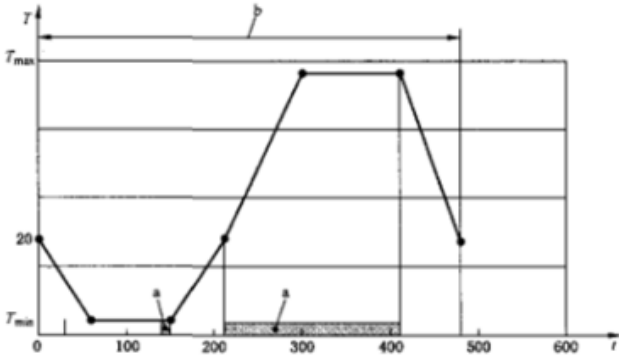
<p>T—Temperature, °C; t—Time, min; a— Mode 3.2; b— 1 cycle.</p> <p>In the period of work mode 3.2, after the whole device temperature reaches -20 °C, the sample is energized, the function of the sample is checked and temperature is 12 V DC between the 210 min and the 410 min in a single temperature cycle, the sample is not energized for the rest of the time;</p>

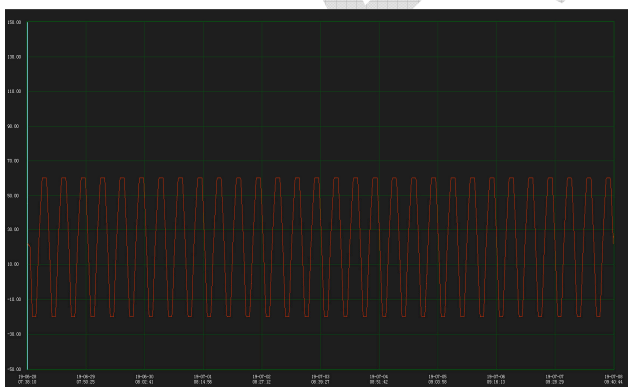
Fig.R08.7 Curves of temperature

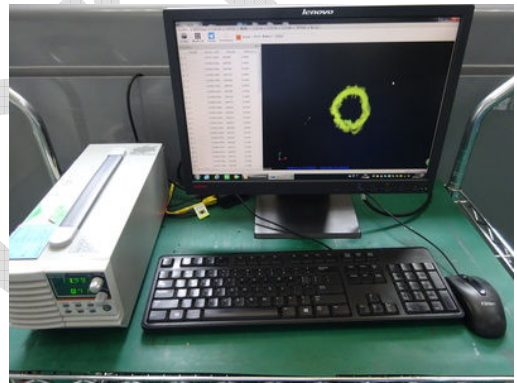
Fig.R12.6 During the test function check schematic photo

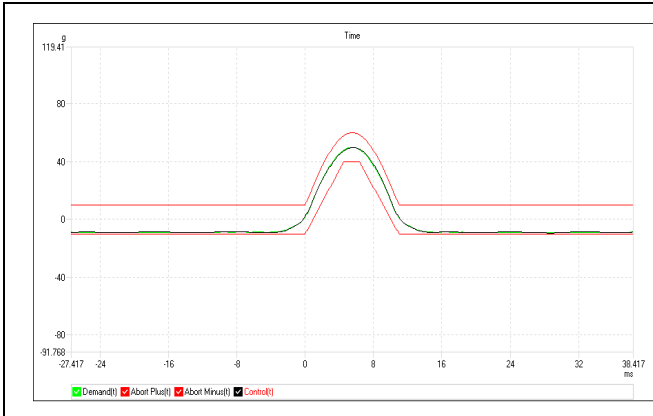
Fig.R15.8 Curves of bump Face 1

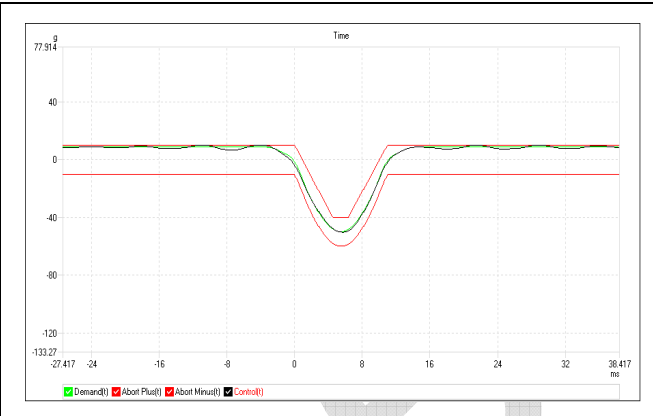
Fig.R15.9 Curves of bump Face 3

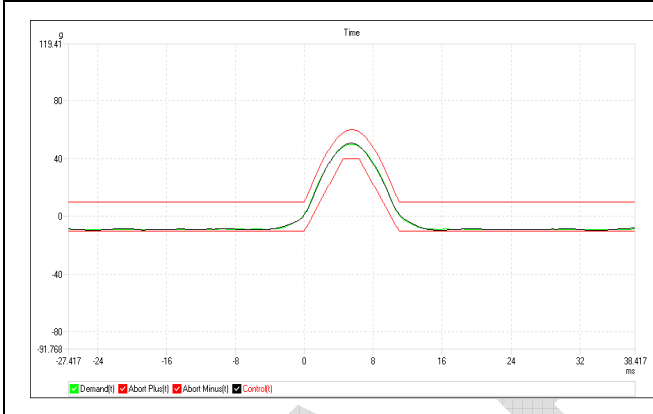
Fig.R15.10 Curves of bump Face 2

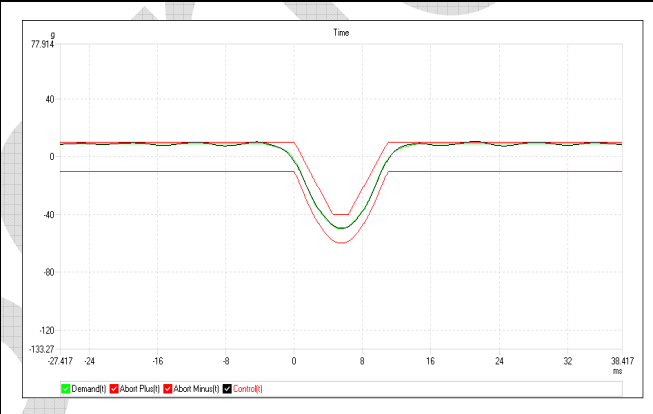
Fig.R15.11 Curves of bump Face 4

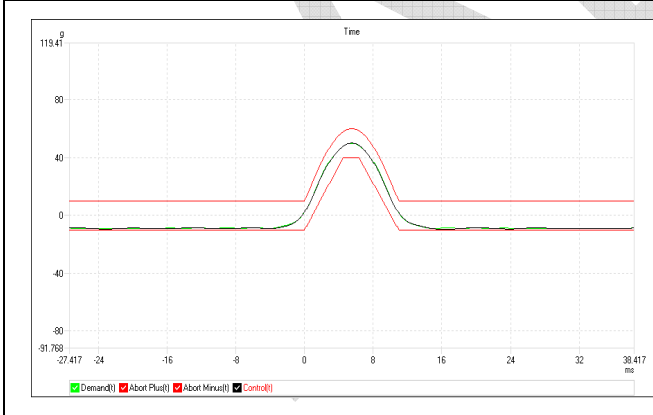
Fig.R15.12 Curves of bump Face 5

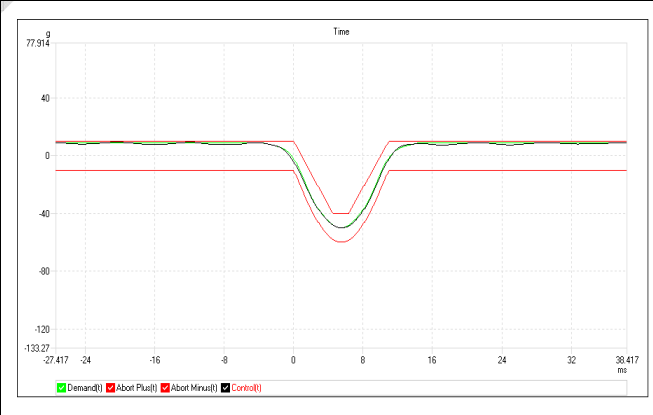
Fig.R15.13 Curves of bump Face 6

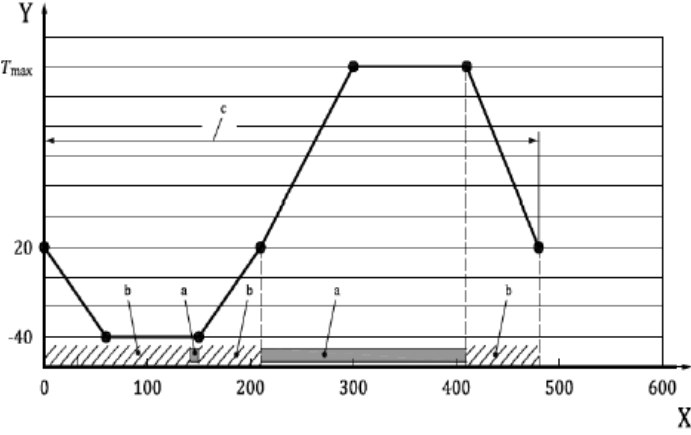
<p>X—Time, min; Y—Temperature, °C; a— Mode 3.2, power on with 12 V DC; c— one cycle.</p> <p>In the period of work mode 3.2, after the whole device temperature reaches -20 °C, the sample is energized, the function of the sample is checked and temperature is 12 V DC between the 210 min and the 410 min in a single temperature cycle, the sample is not energized for the rest</p>

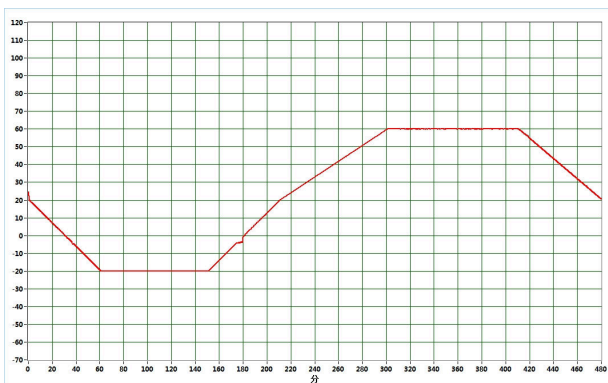
Fig.R16.8 Curves of temperature X axis

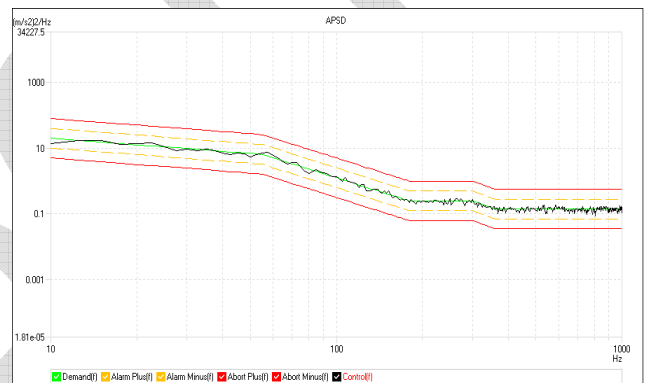
Fig.R16.9 Curves of vibration X axis

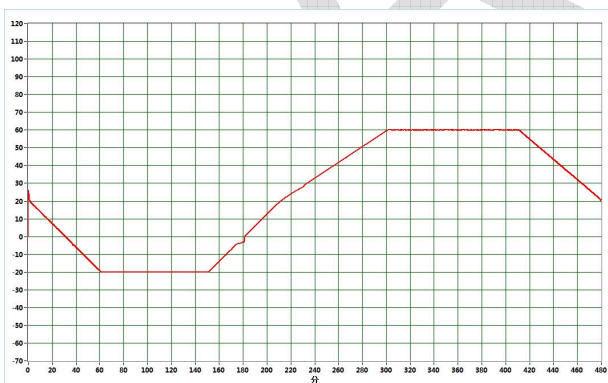
Fig.R16.10 Curves of temperature Y axis

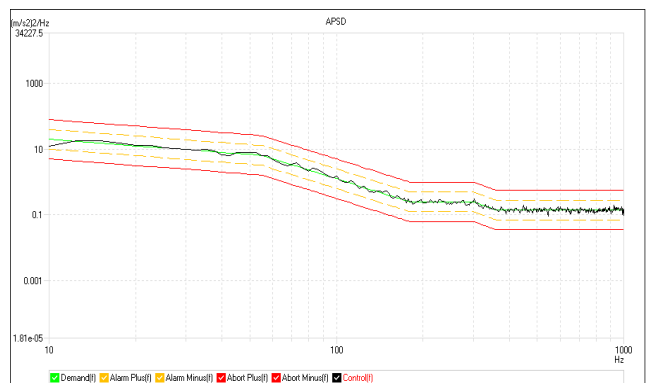
Fig.R16.11 Curves of vibration Y axis

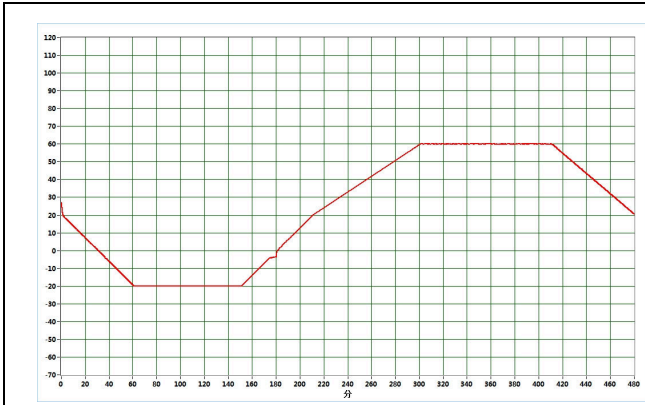
Fig.R16.12 Curves of temperature Z axis

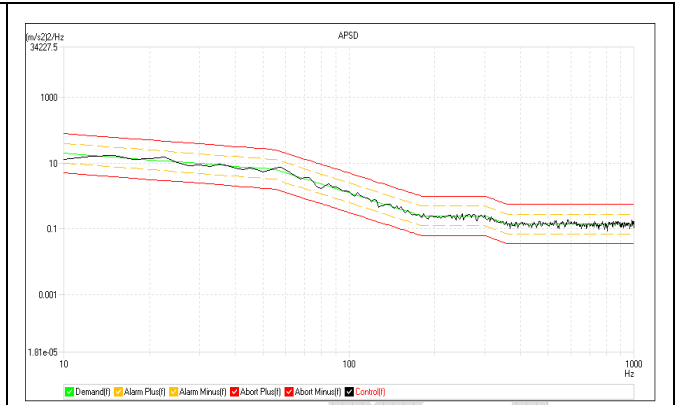
Fig.R16.13 Curves of vibration Z axis

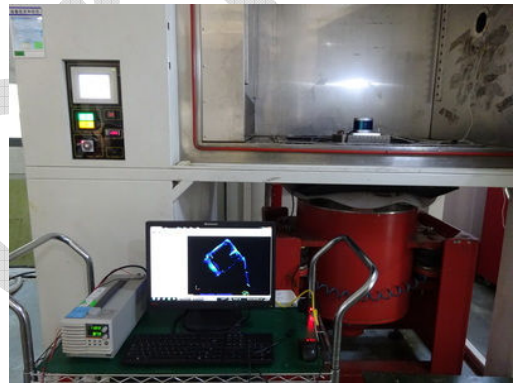
Fig.R017.4 During the test setup schematic photo

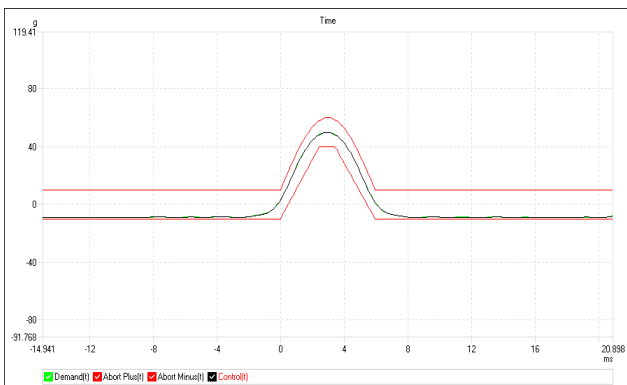
Fig.R17.8 Curves of shock +X axis

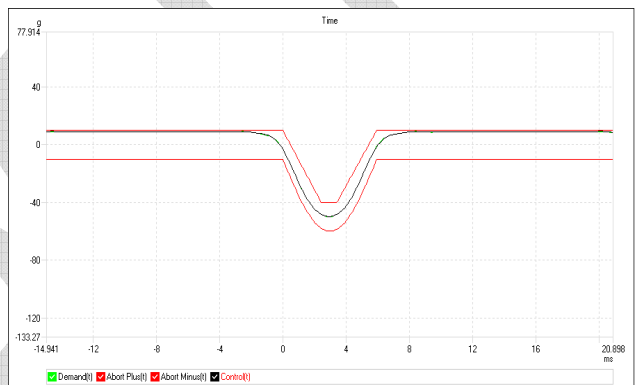
Fig.R17.9 Curves of shock -X axis

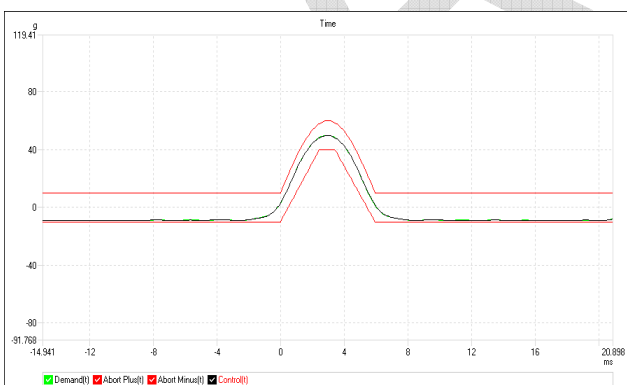
Fig.R17.10 Curves of shock +Y axis

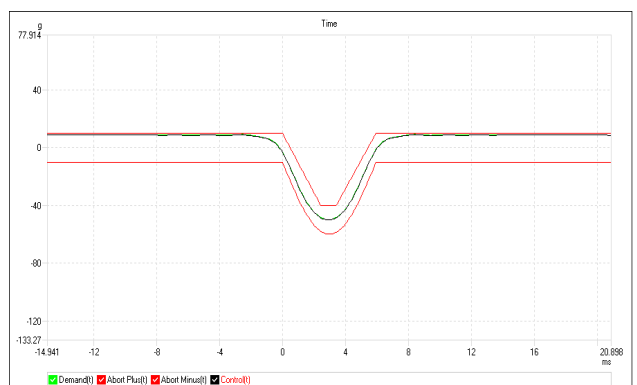
Fig.R17.11 Curves of shock -Y axis
